RESEARCH MEMORANDUM

VIBRATION SURVEY OF BLADES IN 10-STAGE

AXIAL-FLOW COMPRESSOR

I - STATIC INVESTIGATION

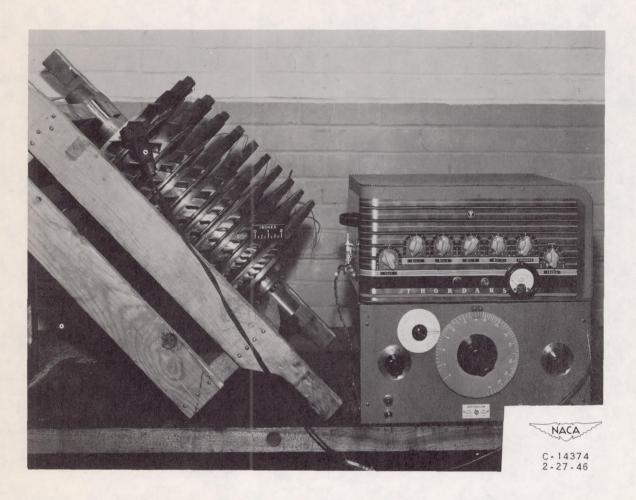
Figure 1. - Electromagnetic coil, amplifier, and oscillator used to determine natural frequencies of compressor blades.

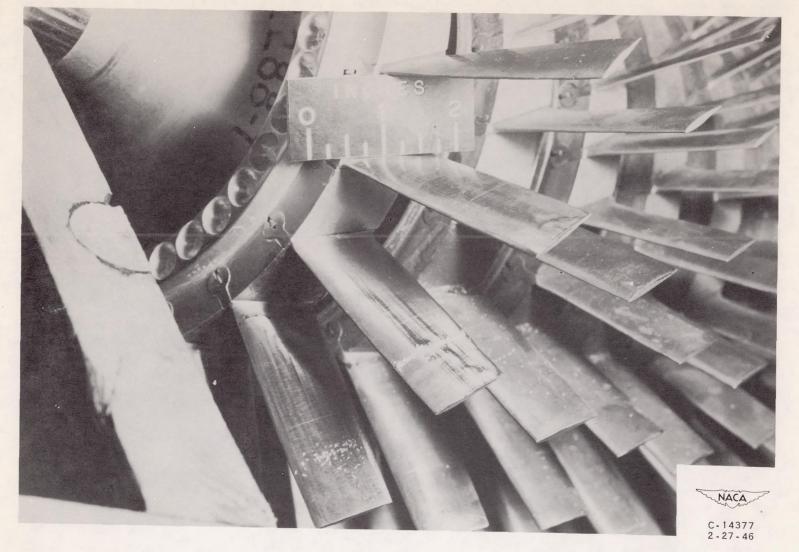
Figure 2. - Sand pattern for second bending-mode vibration on first-stage blade. Frequency of vibration, 1940 cycles per second.

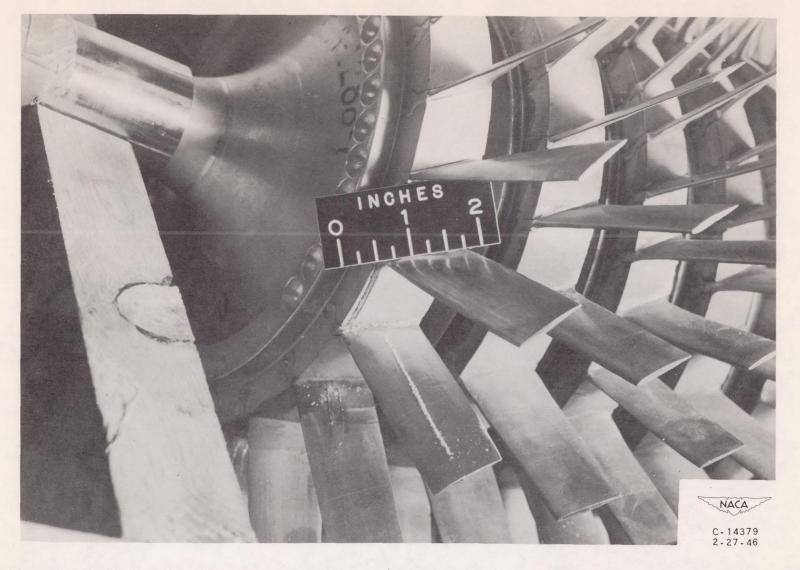
Figure 3. - Sand pattern for first torsional-mode vibration on first-stage blade. Frequency of vibration, 2820 cycles per second.

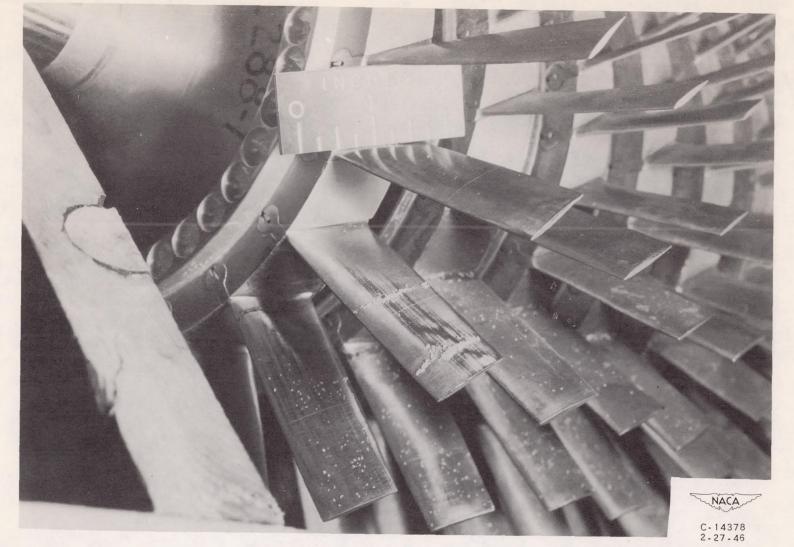
position about one-third the distance from the root to the nearest node for the third bending-mode vibration photographed. This position is approximately the location of failure in the seventh and tenth stages when distances are proportioned according to total blade length. Consequently, in bending vibration only the first or second modes could cause the failures. In the torsional modes of vibration (figs. 3 and 5), the maximum-stress areas indicated by the node position are located at the leading and trailing edges near the blade root. Theoretically, the maximum stress for an airfoil-shaped bar is along the maximum blade thickness provided that the ends are permitted to warp at will. When the blade is rigidly restrained, however, the maximum-stress regions originate at the leading and trailing edges near the root and shift toward the center of the chord farther along the length of the blade. This conclusion was verified by data obtained from numerous resistance-wire strain gages cemented near a blade root in three directions of orientation, and by fatigue failing several blade specimens in torsion with a pneumatic vibrator. Torsional modes can therefore be disregarded because torsion would result in fatigue starting at the leading and trailing edges rather than at the maximum blade thickness. The node shapes on the blades of the seventh and ninth stages are distorted and the torsional modes therefore must be considered (fig. 8). The significance of the torsional modes might be more accurately evaluated from strain-gage data taken during engine operation.

Figure 4. - Sand pattern for third bending-mode vibration on first-stage blade showing location of two nodes other than one at blade root. Frequency of vibration, 5200 cycles per second.

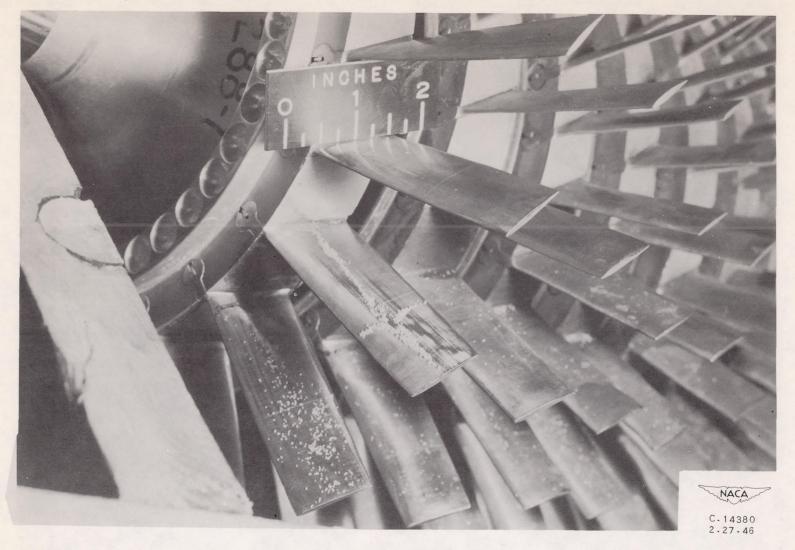
Figure 5. - Sand pattern for second torsional-mode vibration on first-stage blade. Frequency of vibration, 6840 cycles per second.

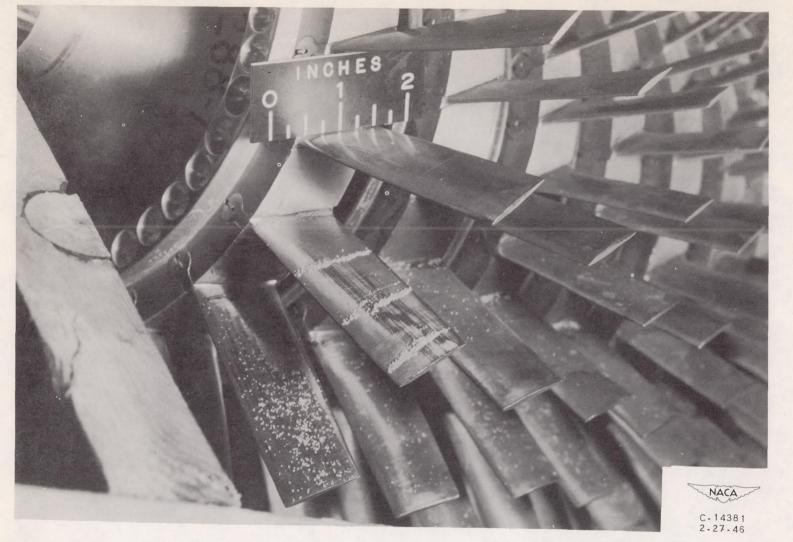
Figure 6. - Sand pattern for fourth bending-mode vibration on first-stage blade. Frequency of vibration, 9600 cycles per second.

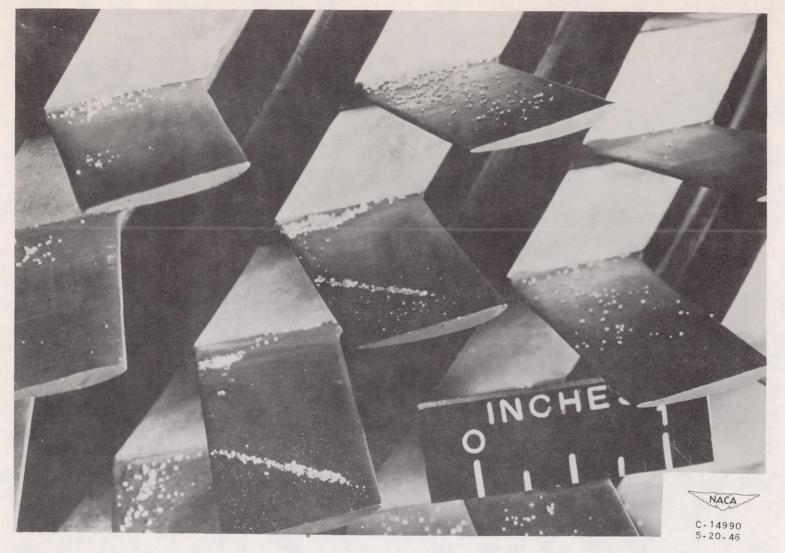
Figure 7. - Sand pattern for second bending-mode vibration on seventh-stage blade showing distorted node shape. Frequency of vibration, 4440 cycles per second.

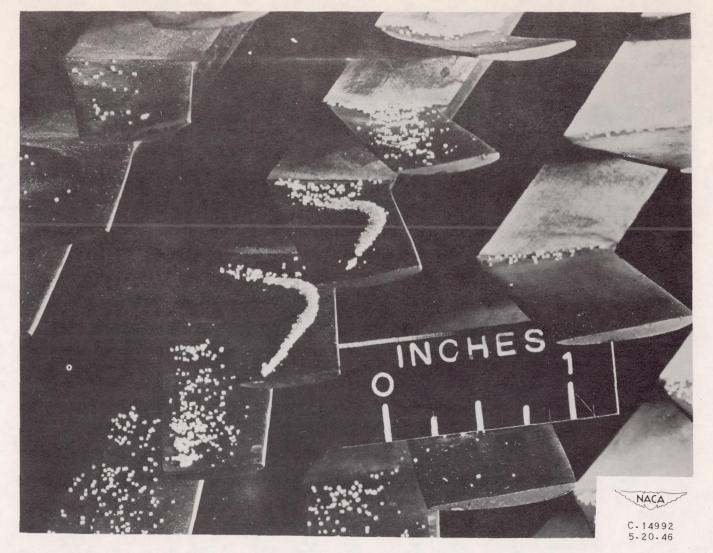
Figure 8. - Sand pattern for first torsional-mode vibration on ninth-stage blade showing distorted node shape. Frequency of vibration, 6160 cycles per second.

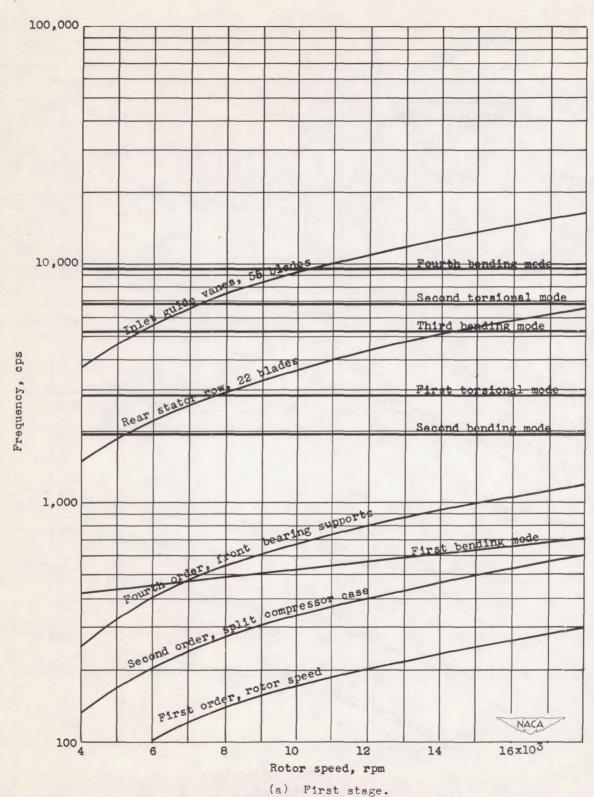
Figure 9. - Critical-speed diagrams for 10 stages of compressor rotor.

A critical speed of 14,400 rpm is indicated on figure 9(a) at a third bending-mode vibration excited in the first-stage rotor blades by the 22 stator blades immediately following. High modes of vibration such as the third bending mode are difficult to excite and are therefore probably not serious. This critical speed is the only one readily apparent in the compressor.

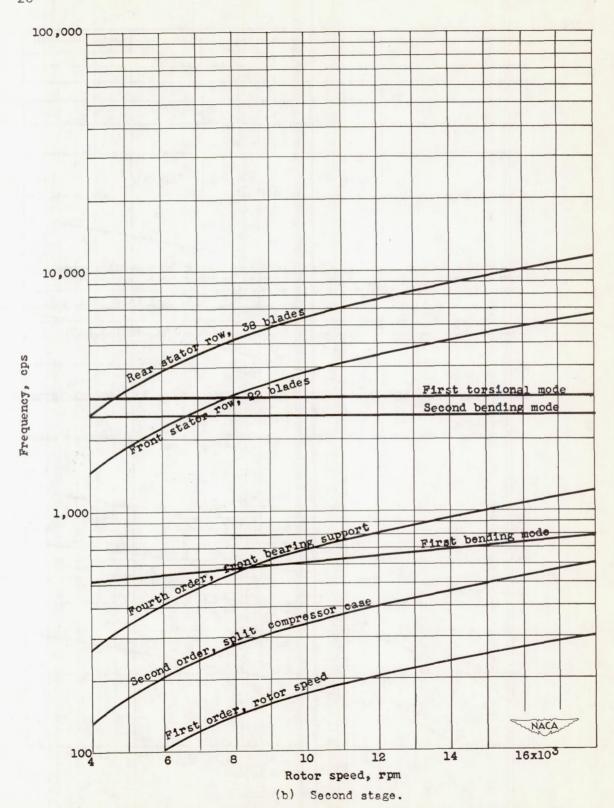
Figure 9. - Continued. Critical-speed diagrams for 10 stages of compressor rotor.

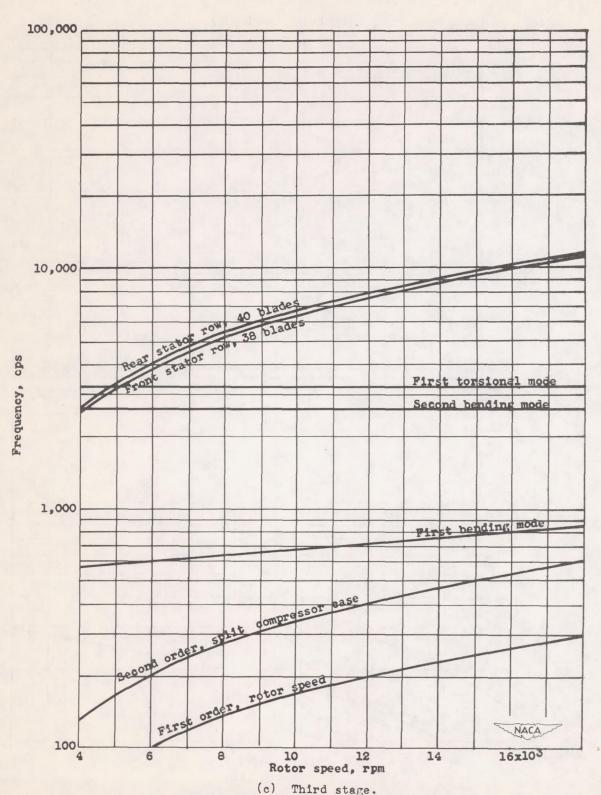
Figure 9. - Continued. Critical-speed diagrams for 10 stages of compressor rotor.

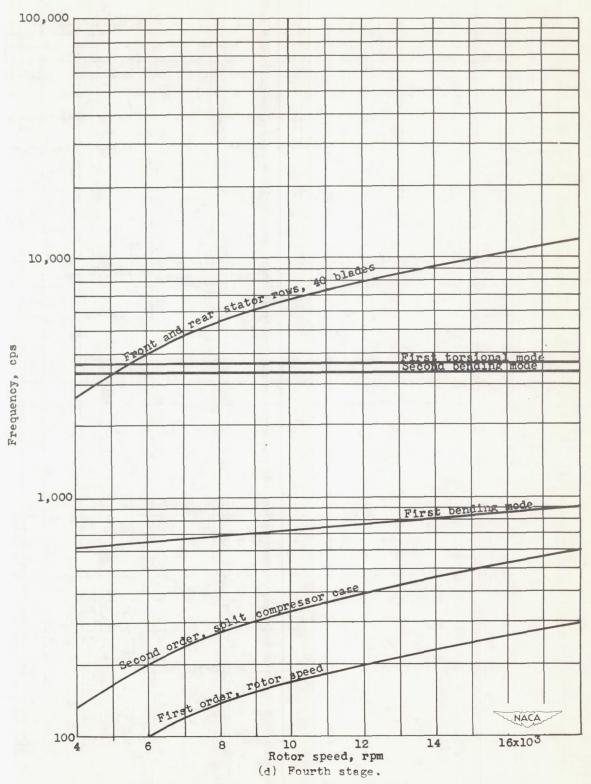
Figure 9. - Continued. Critical-speed diagrams for 10 stages of compressor rotor.

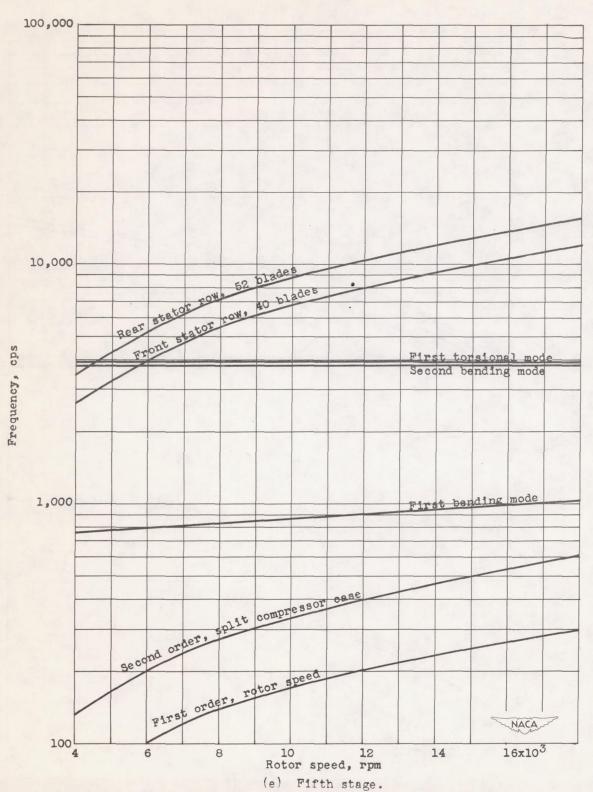
Figure 9. - Continued. Critical-speed diagrams for 10 stages of compressor rotor.

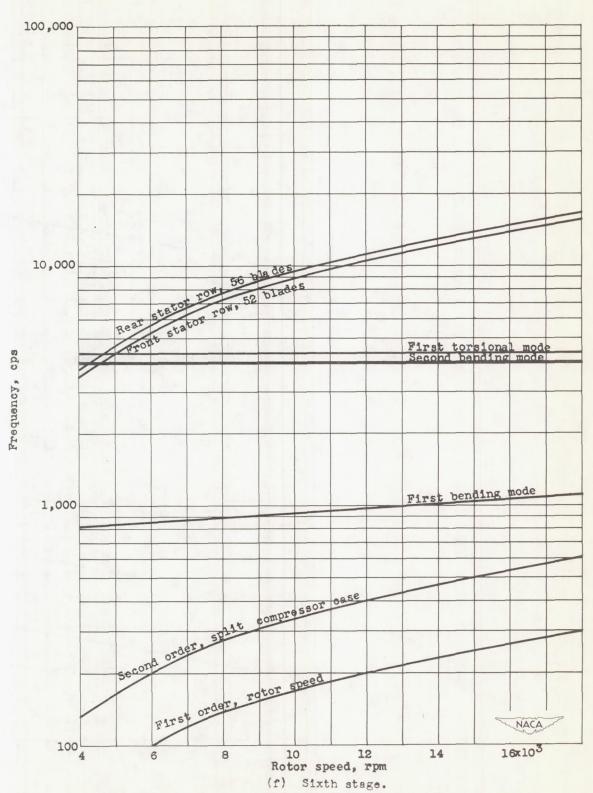
Figure 9. - Continued. Critical-speed diagrams for 10 stages of compressor rotor.

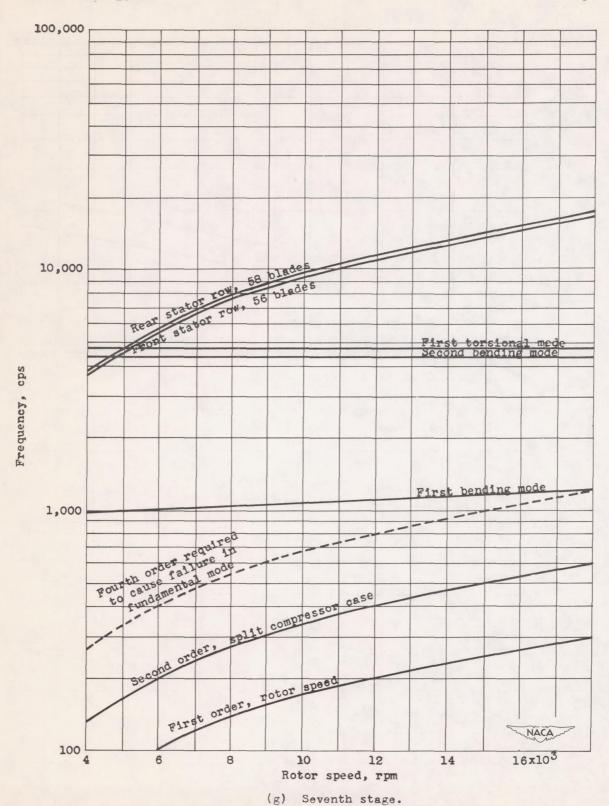
Figure 9. - Continued. Critical-speed diagrams for 10 stages of compressor rotor.

Within the operating range of the engine, the exciting force required to cause a resonant vibration in the seventh-stage blades in the first bending mode is approximately the fourth order of the rotor speed (fig. 9(g)). The only fourth-order exciting force obviously present in the compressor is caused by the four arms supporting the front main bearing but it is doubtful that the effect of the arms would carry through as far as the seventh stage. In the tenth stage, the resonant point of first bending-mode vibrations at 16,600 rpm coincides exactly with a sixth-order excitation (fig. 9(j)). The blades are possibly being mechanically or aerodynamically excited but no exciting force of these orders could be determined. All the failures reported occurred in complete engines and, although a compressor has been operated at various speeds up to 17,000 rpm in an NACA test cell for more than 450 hours, no failures have occurred. Some coupling effect might possibly take place between the turbine or the accessories and the compressor during complete engine operation. Operation at high pressure ratios may also produce the air-flow velocities and pressure conditions necessary to excite blade flutter.

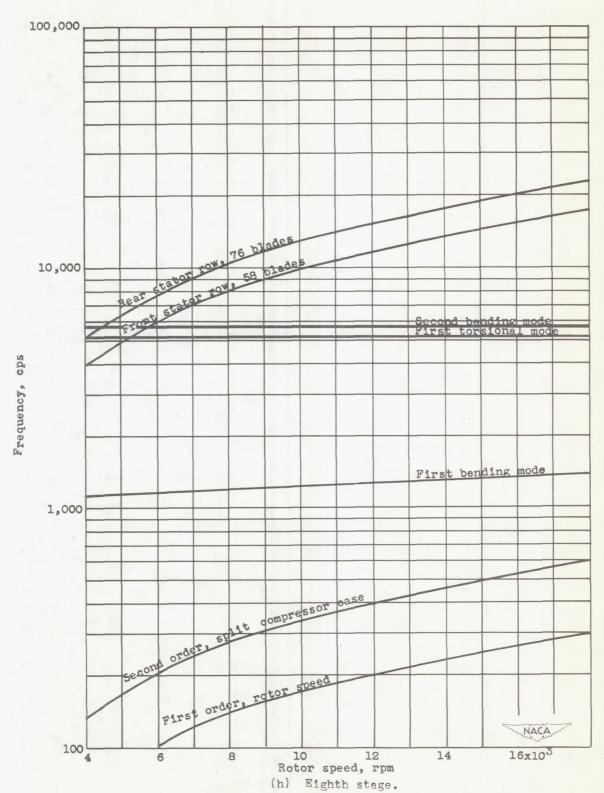
Figure 9. - Continued. Critical-speed diagrams for 10 stages of compressor rotor.

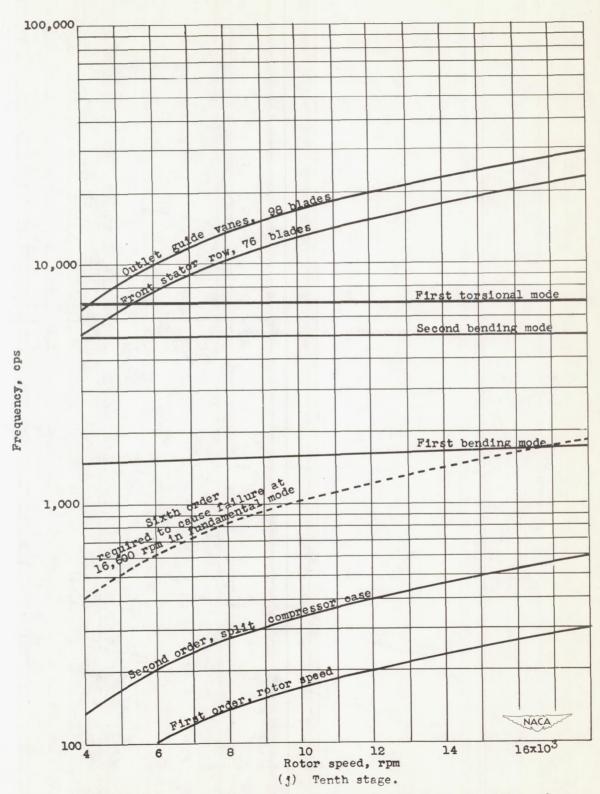
Figure 9. - Concluded. Critical-speed diagrams for 10 stages of compressor rotor.

Results of an investigation to determine the reason for failure of blades of the seventh and tenth compressor stages in the 10-stage axial-flow compressor at a speed of 16,600 rpm indicated a possibility of exciting first bending-mode vibrations in the seventh-stage blades by a fourth-order excitation of the rotative speed. The tenth-stage blades were possibly excited in the first bending mode by a sixth-order excitation.
